U.S. Department
of Transportation
**Federal Aviation
Administration**

ADVISORY CIRCULAR 43-16A

AVIATION MAINTENANCE ALERTS

ALERT
NUMBER
301

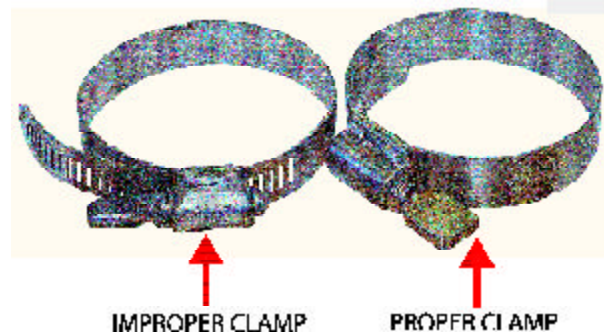
Beech; Model B36TC; Bonanza; Improper Clamp Installation Causes Landing Gear Failure; ATA 2120

a “pig-tail” which caught on the right inboard of the landing gear door rod/bellcrank assembly and forced it off of the duct and onto the landing gear relay (P/N SM 50D7). The clamp shorted the gear relay and rendered the landing gear inoperative in normal mode.

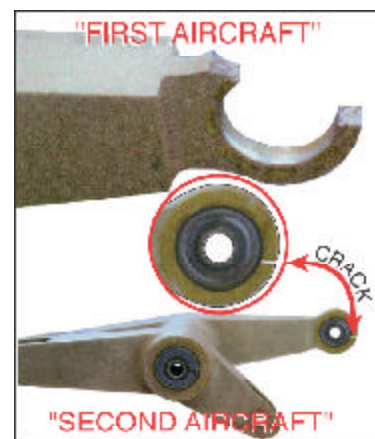
SABRELINER**Sabreliner; Model NA-265-65; Sabre 65; Broken Elevator Bellcrank; ATA 2730**

After finding the left aft elevator bellcrank cracked at the lower bearing boss area, the technician decided to perform an inspection on the five additional Sabreliner NA-265-65 aircraft that were located at the facility. The inspection revealed one additional cracked bellcrank at the same location.

The submitter recommends that the operators perform a close visual or eddy-current inspection of the lower bearing boss. At this time, the cause of the failures has not been determined. The weakened boss area could have resulted from the combination of high cable tension, bias loading of the elevator cables, and line staking the bearing boss area during manufacture.

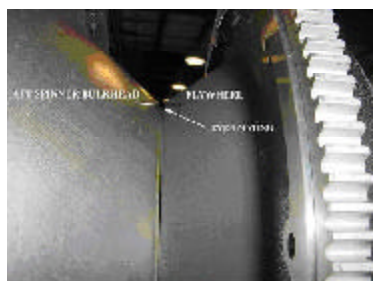
Figure 1. Correct Installation.

The propeller installation section of the Tiger Aircraft AA-5 series and AG-5B Aircraft Maintenance Manual (AMM) includes a 'CAUTION' statement, which warns that the aft spinner bulkhead can be damaged if not held securely in place during propeller installation. A temporary means of securing the aft spinner bulkhead, to insure that it is seated properly onto the crankshaft flange bushings, is recommended by the AMM. It is recommended that maintenance personnel familiarize themselves with the propeller installation procedure, as defined in the AMM, and abide by the 'CAUTION' statements. Furthermore, it is recommended that inspectors performing annual/100-hour inspections (during which access to the subject area is available for scheduled maintenance tasks) visually inspect the aft spinner bulkhead to starter ring gear mating to insure even fit around the mating surface (see Figures 1 and 2). The spinner to propeller fit and clearance can also provide an indication of a misaligned aft spinner bulkhead (see Figures 3 and 4).

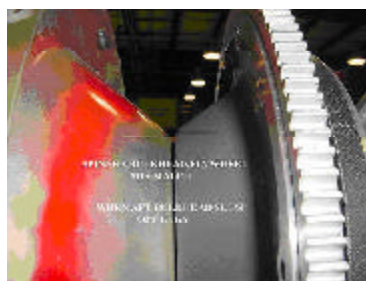
Figure 2. Incorrect Installation.

An investigation determined that four of the six mounting holes of the aft spinner bulkhead had a crescent-shaped sheared-off arc area that made the holes appear elongated. Further analysis revealed that this was caused by the aft spinner bulkhead being pinched between the propeller spacer and the crankshaft flange bushings. It was determined that this condition was the result of aft spinner bulkhead misalignment during the installation process. During installation of the propeller, the aft spinner bulkhead slipped-off of the crankshaft flange bushings and rested against the propeller bolts. Once the bolts were torqued in the misaligned condition, the result was the aft spinner bulkhead wedged between the propeller spacer and the crankshaft flange bushings. Eventually the spinner bulkhead wore through creating crescent-shaped sheared-off arc areas, and the propeller became loose.

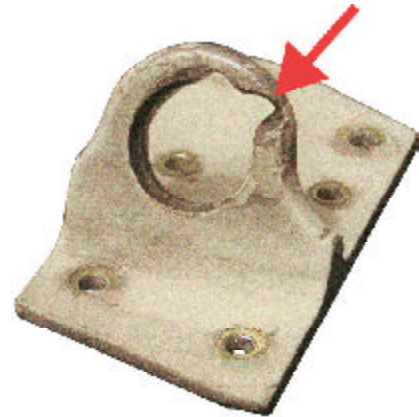
McDonnell Douglas; Model 369D; Worn Shoulder Harness Attach Fitting; ATA 2510

During a conformity inspection on a leased aircraft, the rear seat shoulder harness attach fittings (P/N 369H3025-1 LH and -2 RH) were found to have an excessive amount of wear on the inside of the “ring” attach fitting. (Refer to the illustration.)

According to the submitter, the right hand fitting had approximately 70 to 80 percent of the ring chafed through, and the left hand fitting had about 15 percent of the ring chafed through.
